Case study: Repair - Bradford Live

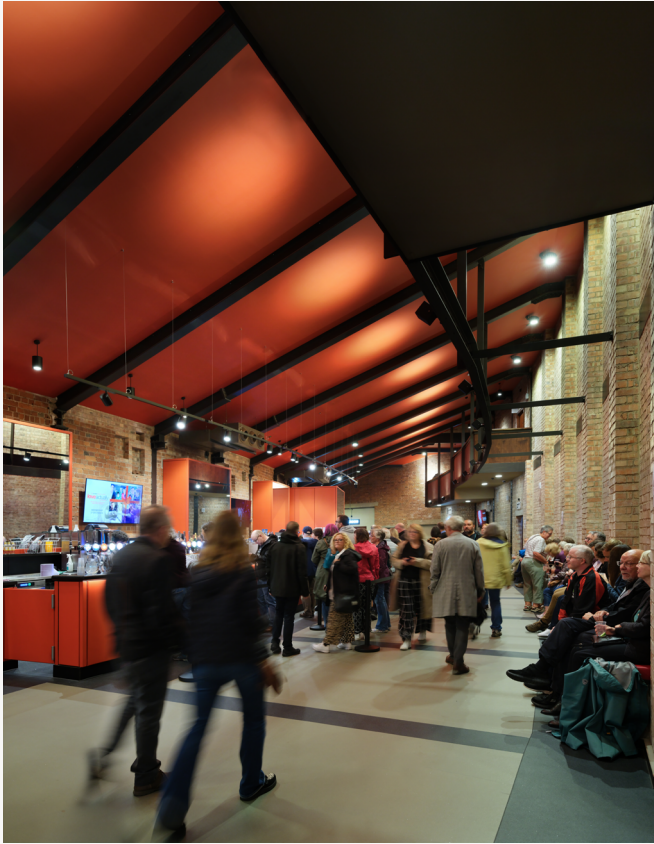
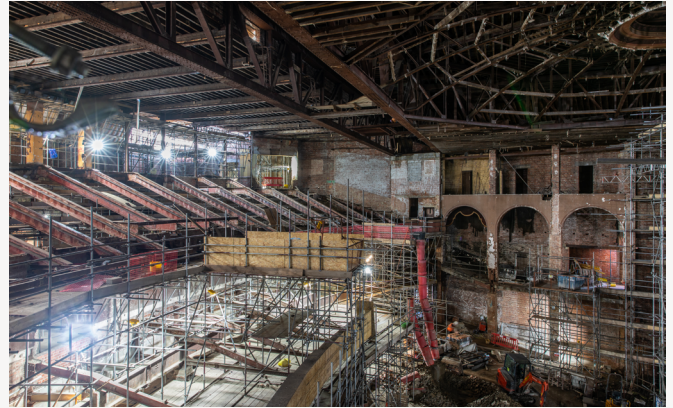
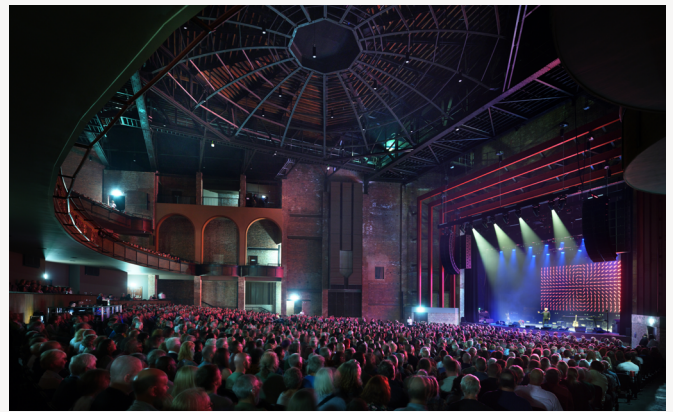
The removal of later intrusive alterations revealed the original auditorium structure for the first time in half a century. With much of the decorative fabric lost, the retained structure became a defining architectural feature, with exposed brickwork, riveted steelwork and new structural elements clearly expressed rather than concealed.

The most significant structural challenge lay in upgrading the roof. Substantial acoustic and thermal enhancements were required, adding considerable load to the existing riveted steel trusses. Rather than wholesale strengthening or replacement, Price & Myers undertook detailed back-calculation of forces through the entire load path, assessing capacity down to

individual rivets to verify what could safely be retained.

Elsewhere, repair and sensitive replacement were key. A severely deteriorated hollow precast and timber plank floor was replaced with a lightweight concrete solution carefully designed to replicate the original dead load. A missing balcony section was reinstated and strengthened to meet modern vibration criteria, while historic iron beams spanning the Bradford Beck were locally repaired where corrosion had occurred.
